REPORT OF APOLLO 204 REVIEW BOARD

**APPENDIX D
PANEL 5**

**REPORT OF PANEL 5
ORIGIN AND PROPAGATION OF FIRE
APPENDIX D-5
TO
FINAL REPORT OF
APOLLO 204 REVIEW BOARD**

ORIGIN AND PROPAGATION OF FIRE

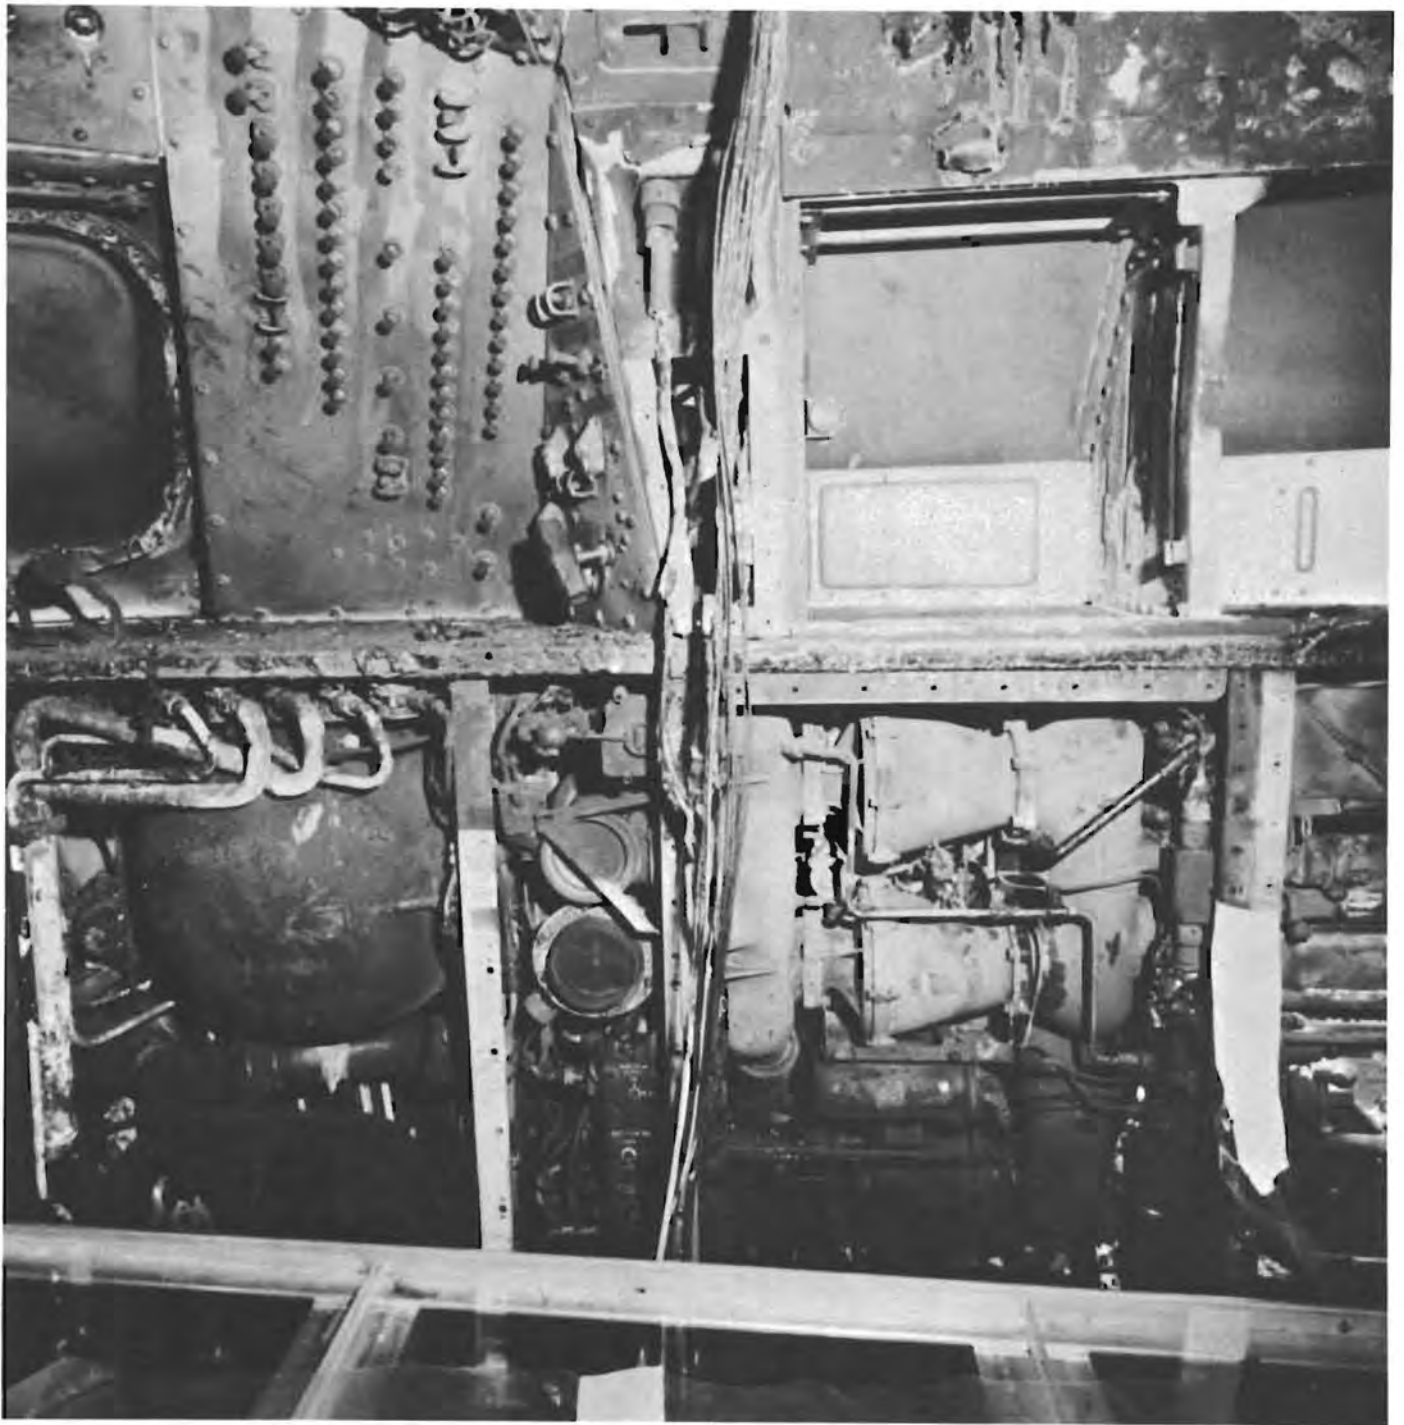
VIEW OF ENVIRONMENTAL CONTROL UNIT

Environmental Control Unit	Insulation completely burned on front of heat exchanger, decreasing fire damage toward rear and left. Tubing on floor separated and melted. Condensate streaks on back wall. Moderate fire damage to floor.
Surge Tanks and One-lb. Oxygen Bottle Area	Hot jet effect upper rear right-hand corner. Heavy soot. Moderate heat damage to insulation on front tubing. Melted plastic adhering to components in area.
Surge Tank, Cabin and Glycol Pressure Relief Valves	Slight to moderate heat damage from top to bottom. Heat damage to insulation on glycol lines. Debris in bottom of bay. Extensive melted plastic adhering to left-hand bulkhead and bottom.

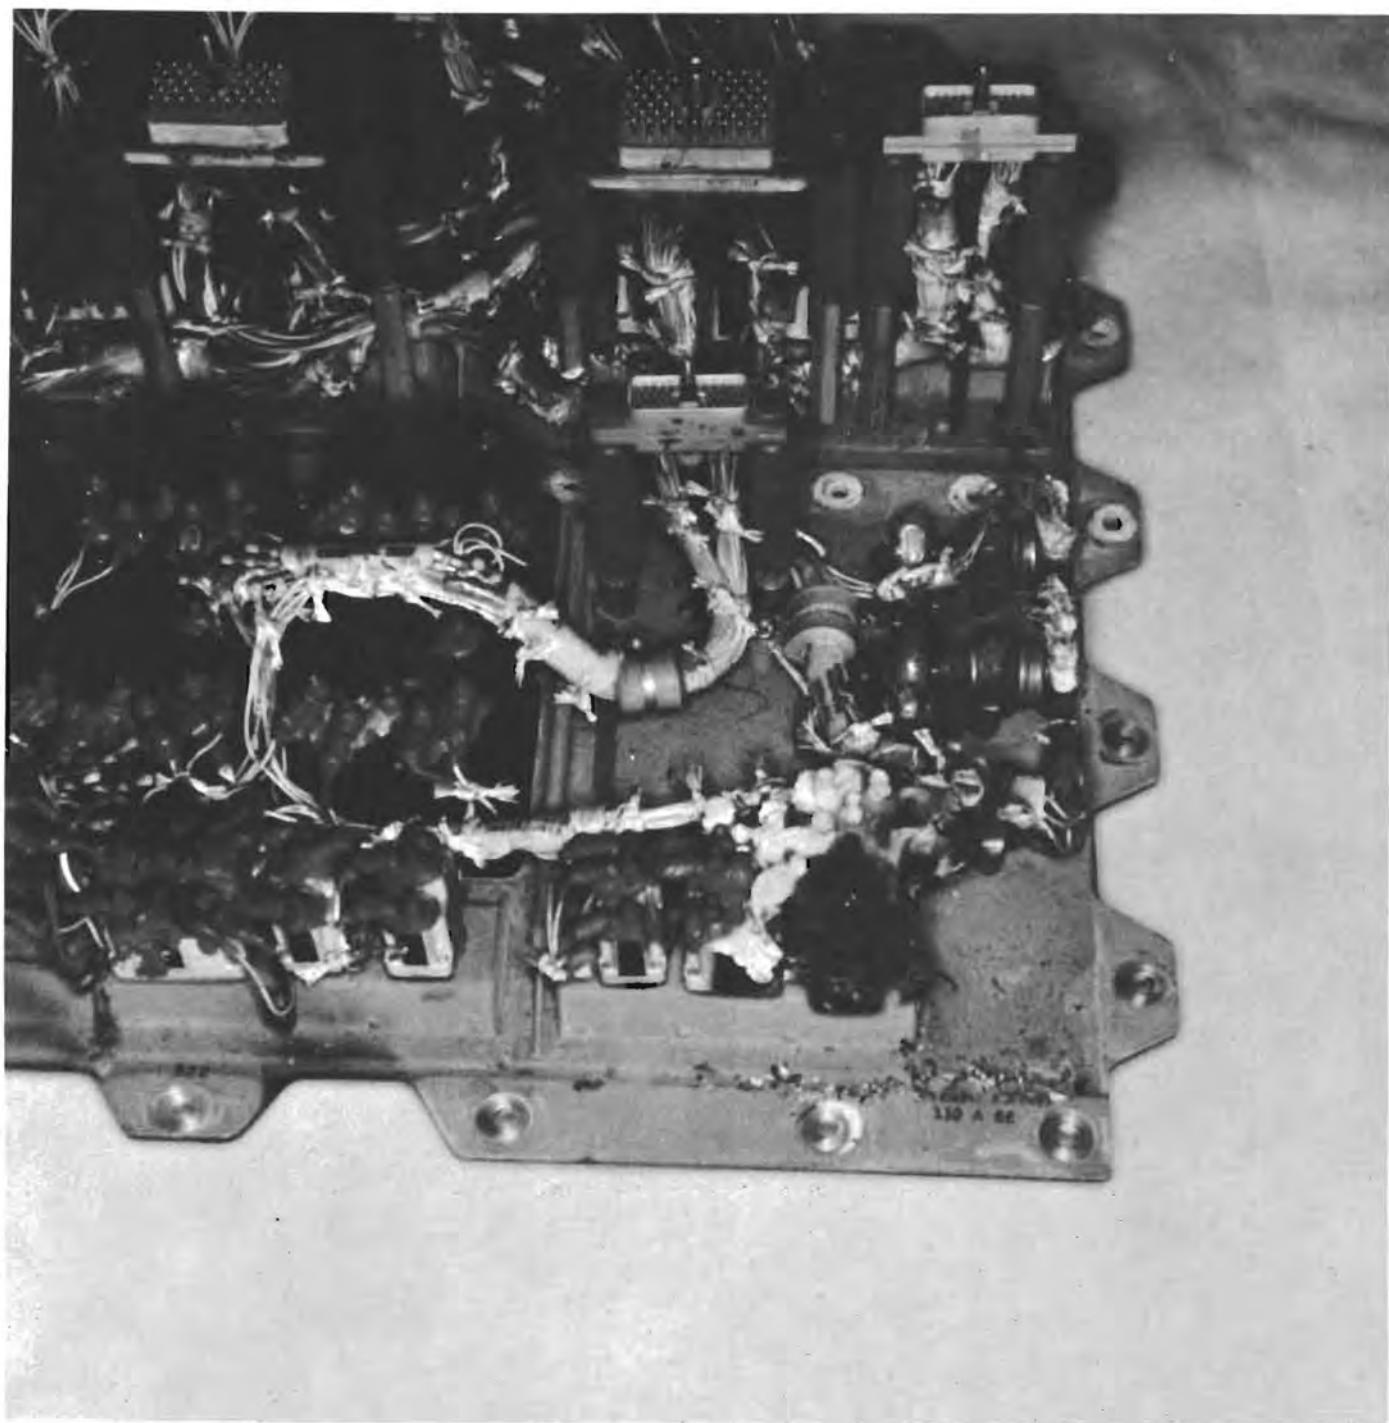
INTERIOR VIEW OF PANEL 13 SHOWING DAMAGE NEAR THUMB WHEELS
